Site HOTO Report — SYL_X0426

Project Tiger · Dhaly Infratech → Alliance Computers Limited · Generated 08-Nov-2026 03:40 BD time

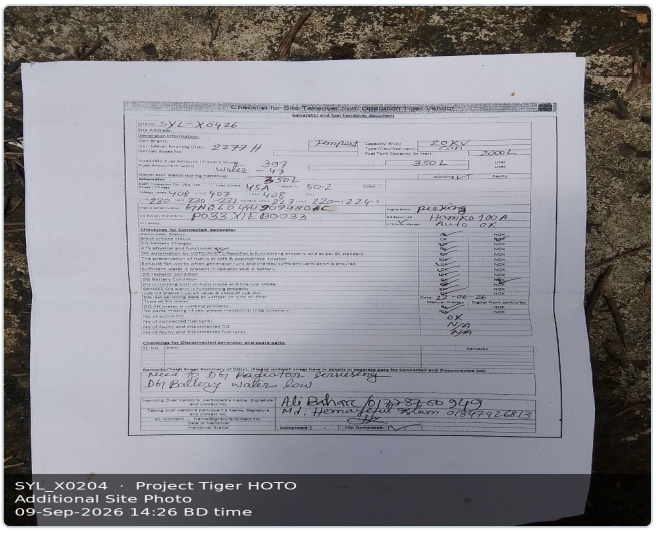
Photo 2 — Handover Checklist Document 1

DG MAJOR DEFICIENCIES	Need to DG Radiator servicing; DG Battery water low (from paper handover checklist).
SAFETY REMARKS	—
GENERAL REMARKS	Technical fields backfilled from a paper handover checklist photo that was misfiled under SYL_X0204's Extra photos (SYL_X0204_EXTRA_045.jpg) -- the document's own printed Site ID field reads SYL-X0426. Photo has been relocated to this visit. IMPORTANT: the Handover Status checkbox on the paper form appears marked "Not Completed", not "Completed" -- please verify with the field team before treating this handover as finalized. Backfilled 2026-09-09.
