Site HOTO Report — SYL_X0213

Project Tiger · Dhaly Infratech → Alliance Computers Limited · Generated 07-Nov-2026 02:51 BD time

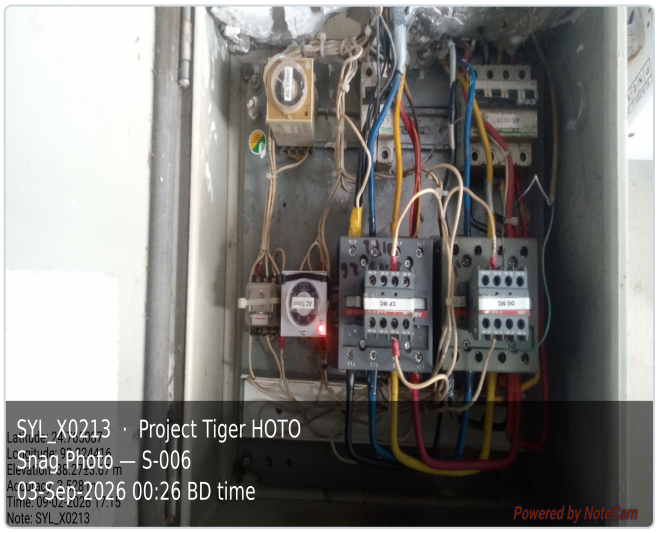
SNAG #	SYSTEM	CATEGORY	COMPONENT	STATUS	OBSERVATIONS	ACTION	PHOTO
S-006	DG	DG - Other	ATS hole filling nok	Not Available	—	Open	
S-007	DG	DG - Other	DG Room Light (□□□□ □□□□ □□□□)	Faulty	—	Open	—

DG MAJOR DEFICIENCIES	ATS hole filling NOK; Room light (DG) faulty
SAFETY REMARKS	—

Photo 4 — S-006 — ATS hole filling nok
