Site HOTO Report — SYL_X0086

Project Tiger · Dhaly Infratech → Alliance Computers Limited · Generated 08-Nov-2026 03:26 BD time

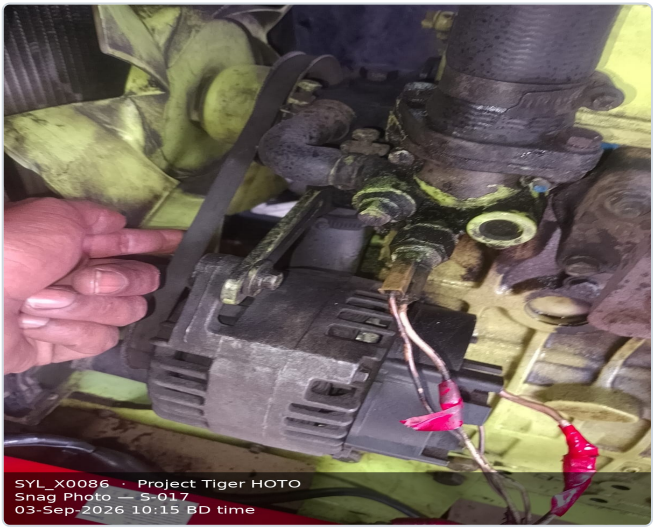
SNAG #	SYSTEM	CATEGORY	COMPONENT	STATUS	OBSERVATIONS	ACTION	PHOTO
S-017	DG	DG - Other	DG fan bet losse	Faulty	—	Open	
S-018	DG	DG - Other	Radiator s blocked with dust.	Faulty	—	Open

DG MAJOR DEFICIENCIES	1) Fan belt loose 2) Rediotor not ciling
SAFETY REMARKS	—
GENERAL REMARKS	PDF checklist notes: DG last servicing date noted 31-7-26. Engine Brand field has original text crossed out and rewritten as illegible 'Perkins' near serial number. Second snag note ('Radiator not ceiling') is ambiguous handwriting - flagged for human review to confirm exact meaning.

Photo 4 — S-017 — DG fan bet losse

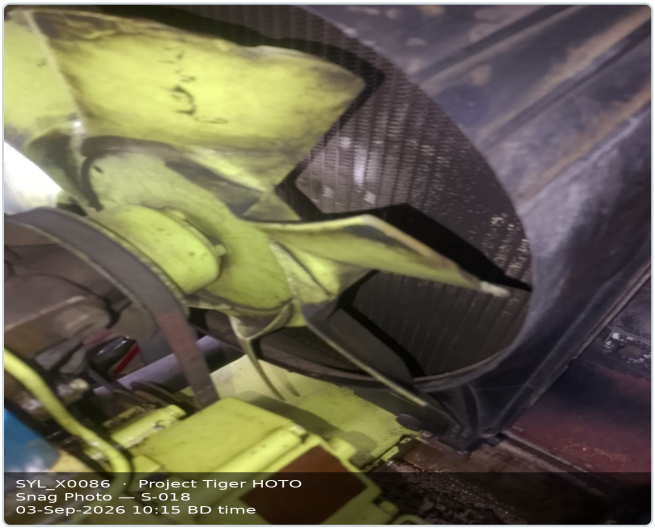
Photo 5 — S-018 — Radiator s blocked with dust.
