Site HOTO Report — SYL_X0156

Project Tiger · Dhaly Infratech → Alliance Computers Limited · Generated 08-Nov-2026 03:54 BD time

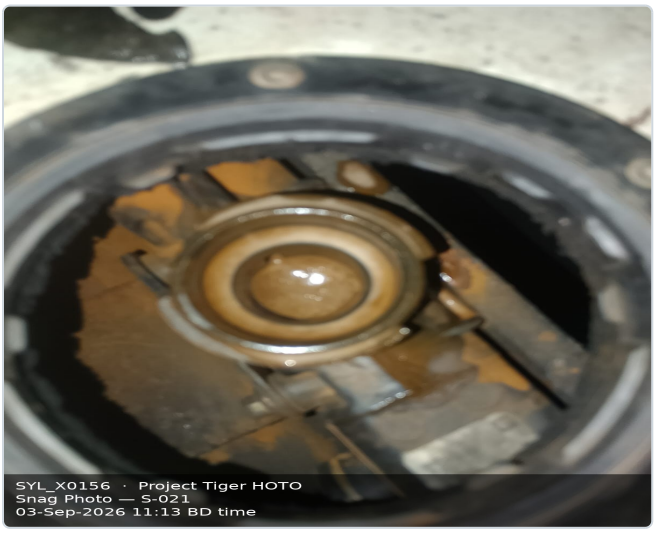
SNAG #	SYSTEM	CATEGORY	COMPONENT	STATUS	OBSERVATIONS	ACTION	PHOTO
S-020	DG	DG - Other	Dg controller display not clean, Nothing on the display is visible	Faulty	—	Open	
S-021	DG	DG - Other	Radiator ful block dust	Faulty	—	Open	
S-022	DG	DG - Other	DG fan belt loose.	Faulty	—	Open

DG MAJOR DEFICIENCIES	Radiator not cooling and leaks; fan belt not OK need to change; controller display not clear

Photo 4 — S-020 — Dg controller display not clean, Nothing on the display is visible
