Site HOTO Report — SYL_G0397

Project Tiger · Dhaly Infratech → Alliance Computers Limited · Generated 08-Nov-2026 03:24 BD time

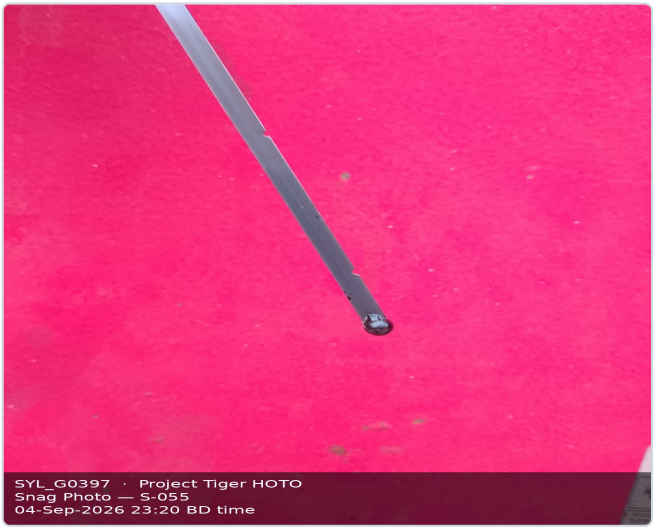
SNAG #	SYSTEM	CATEGORY	COMPONENT	STATUS	OBSERVATIONS	ACTION	PHOTO
S-055	DG	DG - Other	DG lube oil empty	Faulty	—	Open	
S-056	DG	DG - Other	servicing date run hour over	Faulty	—	Open	
S-057	DG	DG - Other	Font site canopy missing	Faulty	—	Open	
S-058	DG	DG - Other	DG back site canopy missing	Faulty	Charging dynamo faulty	Open

Photo 4 — S-055 — DG lube oil empty

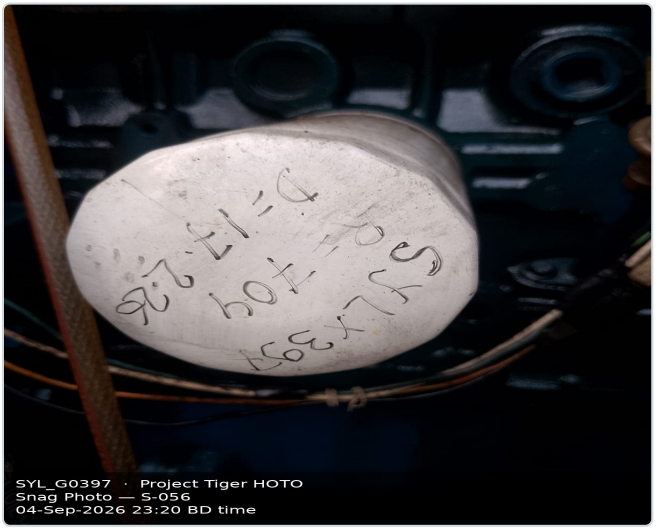
DG MAJOR DEFICIENCIES	Lube oil shortage; charging dynamo faulty; DG front-site and back-site canopy missing; DG overhauling needed
SAFETY REMARKS	—
GENERAL REMARKS	PDF checklist notes: This form has a different layout/orientation than the DHK-series sites (checklist rows appear shifted/misaligned relative to OK/NOK columns due to a skewed scan), so item-by-item OK/NOK correlation is lower-confidence - several rows show checkmarks that may be offset by one row. Black smoke status and DG battery charger both appear NOK. Available Fuel Amount field has one figure written and crossed out ('80') with '124 L' and 'eighty eight L' both present - genuinely ambiguous, flagged for human review. Site Address left blank. Date of Handover explicitly written as 4-9-26 in the signature block (distinct from top-of-page date, which was not clearly visible in this crop). DG last servicing date shows 17-2-2026, quite old relative to handover date - also flagged.

Photo 5 — S-056 — servicing date run hour over

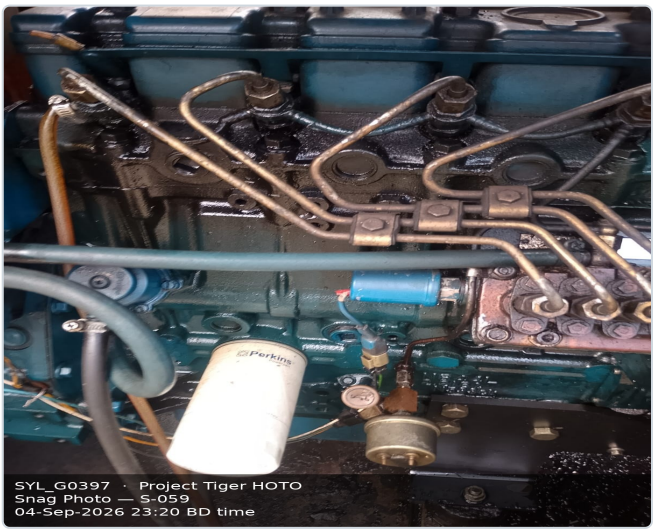
S-059	DG	DG - Other	Need to overhaling	Faulty	—	Open

Photo 8 — S-059 — Need to overhaling
